Innes McCartney

JUTLAND 1916

THE ARCHAEOLOGY OF A NAVAL BATTLEFIELD

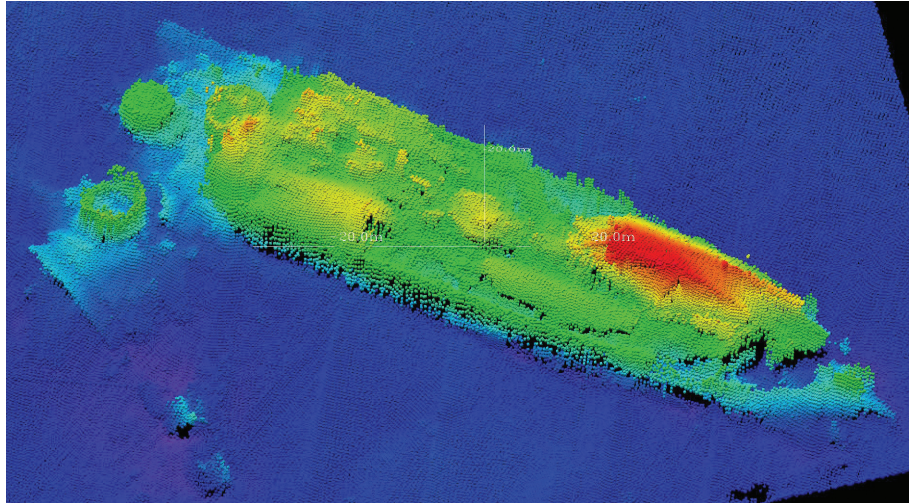
Fig. v Multibeam image of the wreck of HMS Audacious, taken in 2008. It shows the wreck to be upside down, with the bows broken away and folded back towards the stern. The extent to which the wreck has collapsed is revealed by its internal features being visible. (Picture: McCartney/MSP)

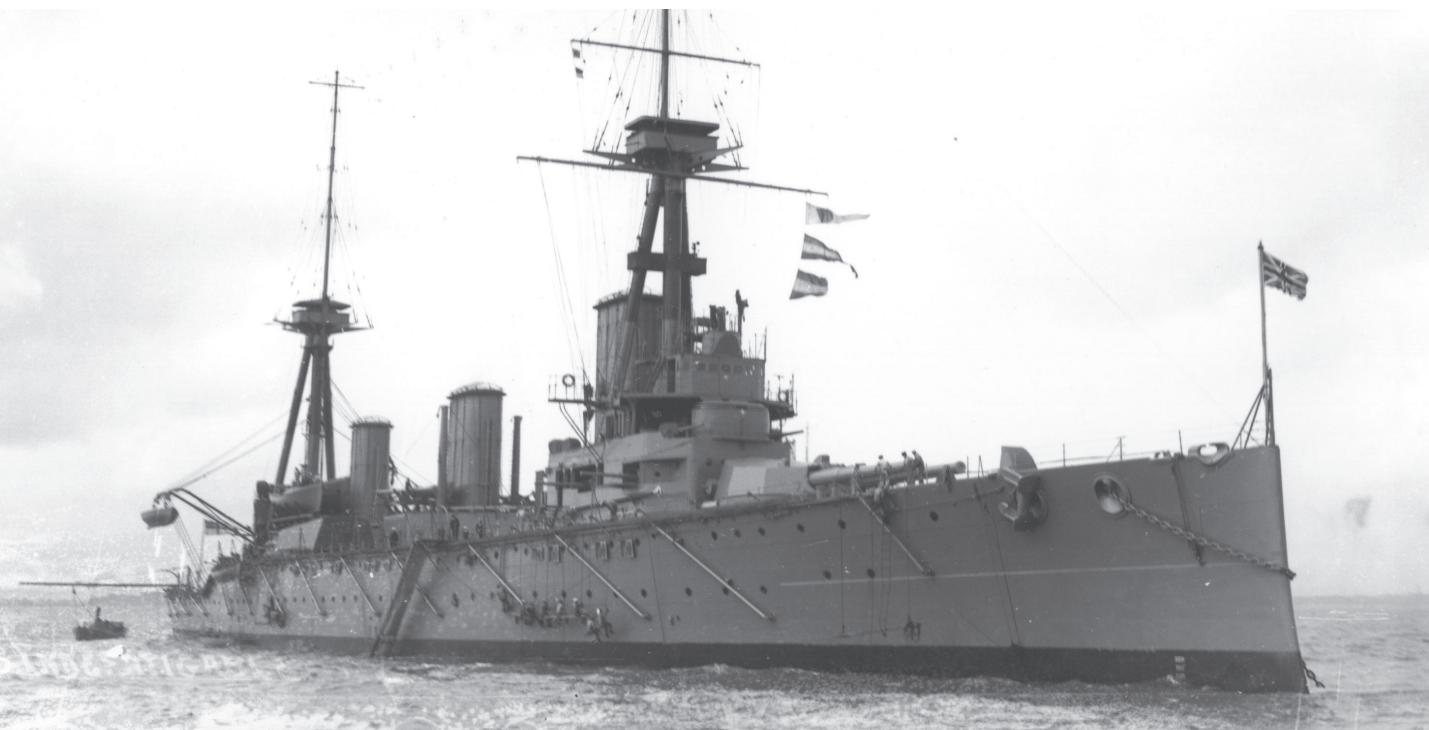
Fig. 1.1 HMS Indefatigable. Displacement: 18,500 tons, length: 555 ft, eight 12-inch guns, sixteen 4-inch guns. (Picture: Topical Press Agency/Getty Images)

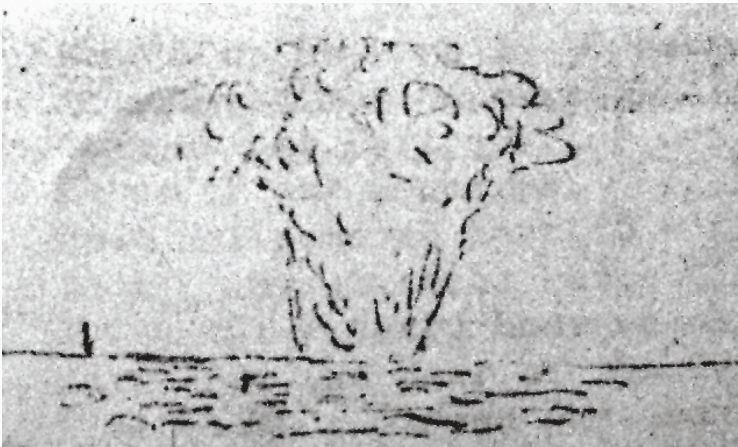
Fig. 1.4 King-Hall's sketch of what was last seen of HMS *Indefatigable*. (Picture: King-Hall, Liddle Collection, Burroughs Papers)

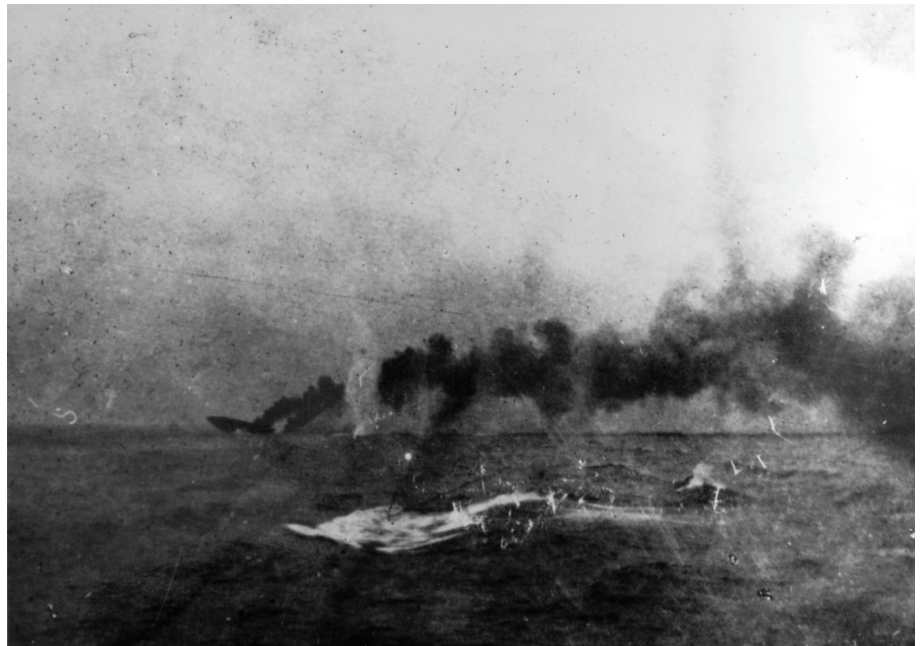
Fig. 1.5 HMS *Indefatigable* sinking by the stern before the reported final explosion, in contrast to Lovett-Cameron's assertion that the ship was intact until she exploded. (Picture: Imperial War Museum Q64302)

Remarkably, there is one photograph that depicts this incident. Other published photos claiming to show the *Indefatigable* sinking are most probably of the *Queen Mary* as will be explained in the next chapter.²⁰ Fig.1.5 was taken by Midshipman WP Carne from the after torpedo control station on the *New Zealand*. This photograph seems to clearly show the *Indefatigable* in her death throes, leaning very heavily to port and sinking by the stern. This fits with the Harper description and with what Oram claimed he saw.

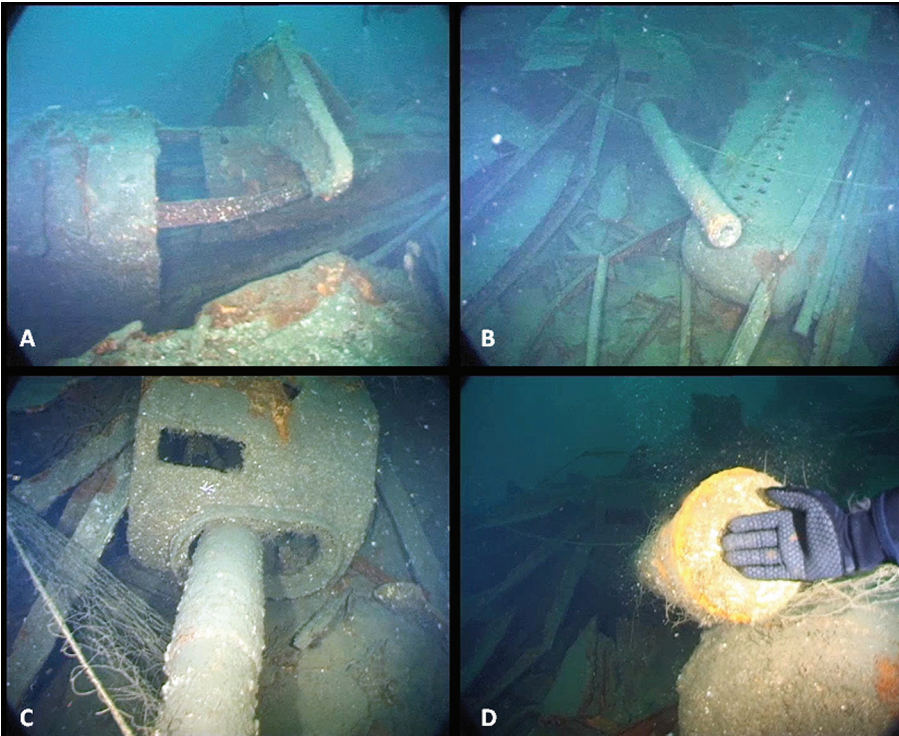
Fig. 1.8 The scattered remains of the wreck of HMS *Indefatigable* as seen in 2001. A shows the crushed remains of a portion of the mainmast. B shows a 4-inch gun lying with its muzzle resting on the remains of a drum from one of the ship's Yarrow boilers. C shows a closer shot of the 4-inch gun with its shield. D shows my hand in the muzzle of the 4-inch gun for scale.

After the dives in 2001 we concluded that in the wreckage were the remains of at least two of the 12-inch gun turrets, at least one 4-inch gun and some of the remains of the ship's 7-inch armour protection. The presence of these items clearly meant that this could not be any other wreck than the *Indefatigable* because the only similar type in the waters of the North Sea was HMS *Invincible* and her wreck had already been conclusively found elsewhere (see [Chapter 5](#)).

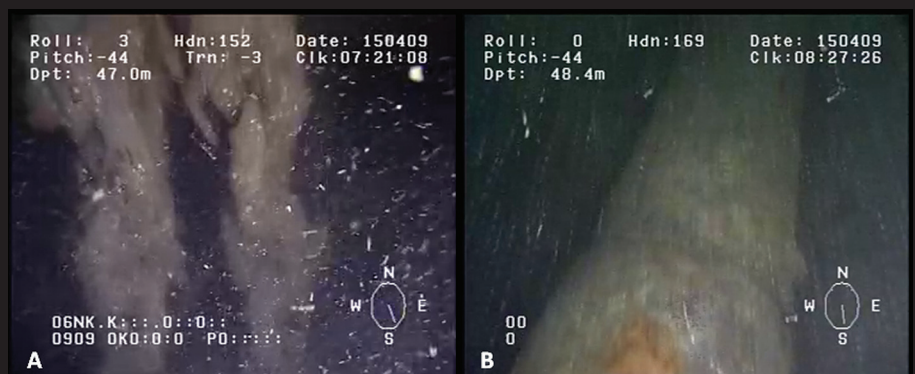
Fig. 1.10 Remains of the fore part of the wreck of HMS *Indefatigable* as recorded by the ROV in 2015. Anchor chains are visible in A, while B shows the barrel of what was probably once one of the guns of 'A' turret.

The navigational systems on *Vina* are all integrated, so once the multibeam image had been analysed it was possible to drop the ROV right on the wreckage to the south-west in order to ascertain whether it represented the bow or stern. Although the underwater visibility was poor, anchor chains were observed, with the double set shown indicating this was *Indefatigable*'s bow. This south-west orientation of the wreck is consistent with the eyewitness accounts and the Carne photograph. From the bow the ROV was then piloted to explore some of the nearby wreckage, including the remains of 'A' turret (Fig.1.10).

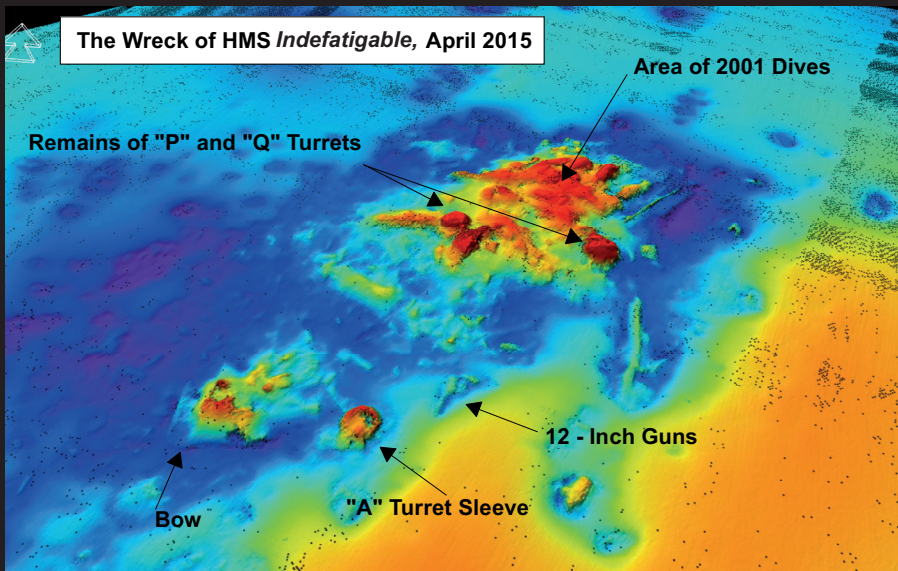
Fig. 1.11 Multibeam image of the *Indefatigable* wreck, with the location of the items identified in 2001 and 2015. (Picture: McCartney/JD-Contractor)

The multibeam had allowed us to understand what the wreck site of *Indefatigable* represented. Clearly the final explosion as she rolled over was located in the fore part of the ship. It seems most likely that the explosion was attributable to the detonation of the magazine under 'A' turret. Even the magazines under 'P' and 'Q' may have exploded. What is more challenging to unravel is why the stern portion of the wreck is so damaged.

From measuring the dimensions of the multibeam image we know the length from the bow to the most north-easterly portion of the wreck to be 140 metres. HMS *Indefatigable* was actually 180 metres long, so some compression of the wreck seems to have occurred as she sank. It may be that the stern was already on the seabed when the second explosion occurred and the ship slipped back on to herself and concertinaed as she settled on the seabed. This would go some way to explaining why the site is so broken up and assumes that a

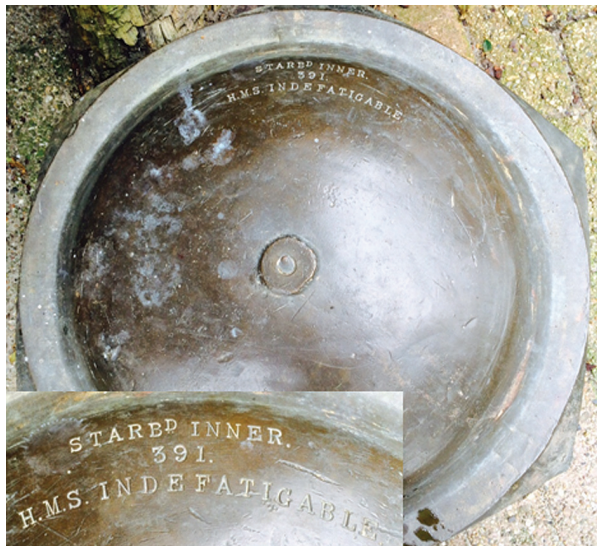
Fig. 1.13 The locking nut from the starboard inner propeller of HMS *Indefatigable* saved by the Terschelling Wreck Museum after the propeller was salvaged. (Picture: Terschelling Wreck Museum)

However, some material evidence of the commercial looting of this wreck does survive. The locking nut (Fig. 1.13) from the starboard inner propeller of HMS *Indefatigable* can be seen at the Terschelling Wreck Museum, alongside other items from the Jutland wrecks. Anecdotally the locking nut was liberated from its propeller after it had been landed in Holland, so it seems that at least one propeller from the wreck site has been salvaged for profit in the past few years.

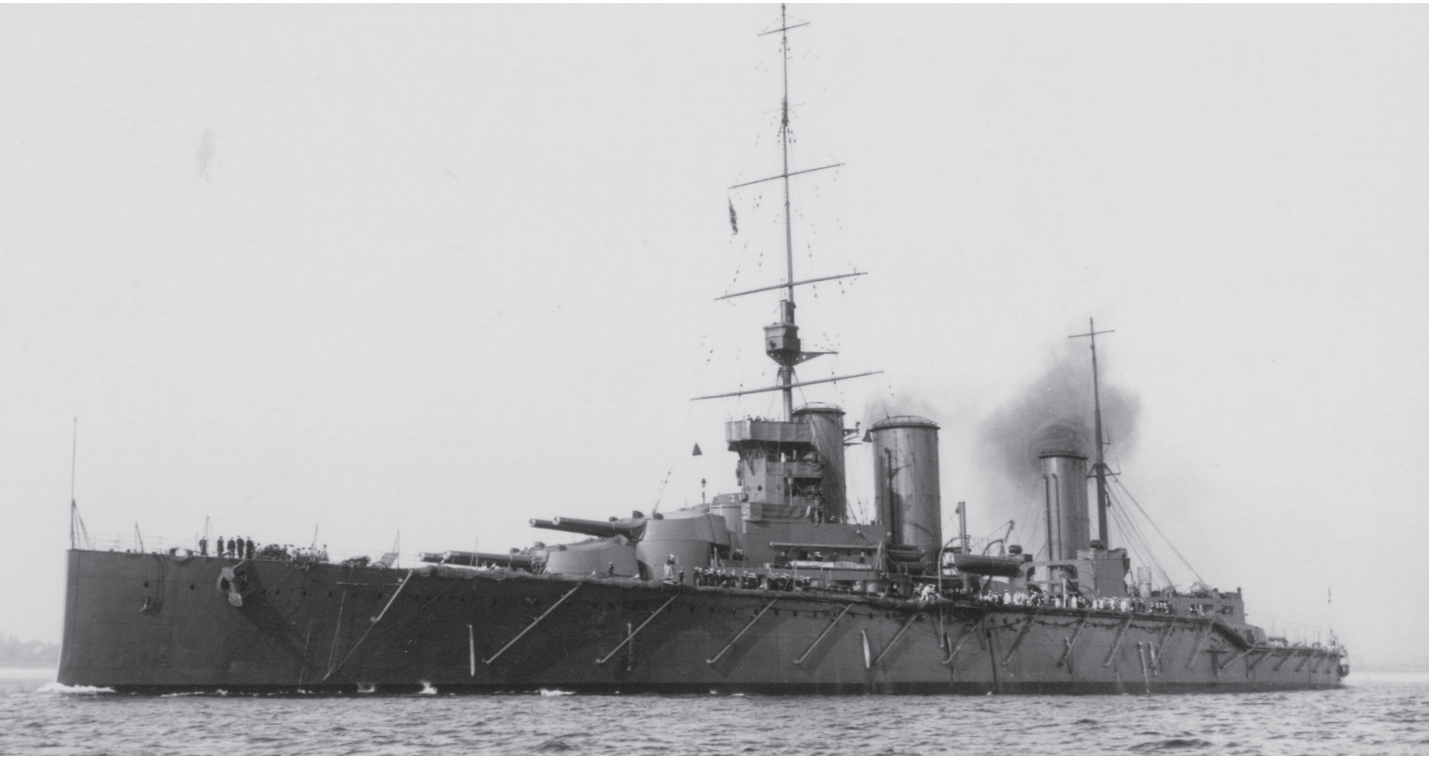
Fig. 2.1 HMS Queen Mary. Launched in 1913. Displacement 26,270 tons, length 660 ft, eight 13.5-inch guns, sixteen 4-inch guns. (Picture: Imperial War Museum Q21661A)

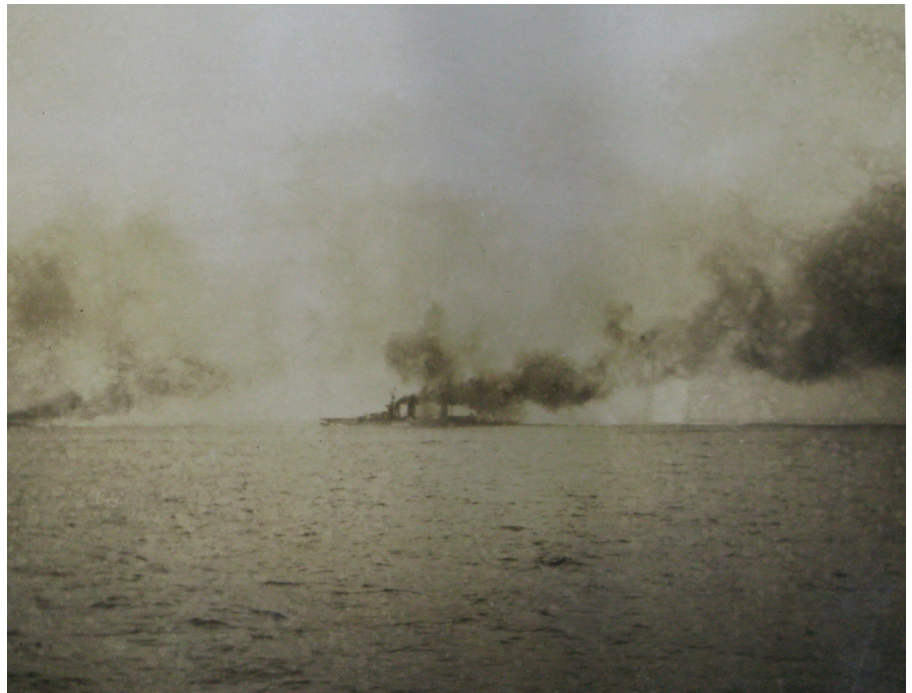
Fig. 2.4 'HMS Lion shots over' is how this photo was described by HMS *Lydiard*'s commanding officer when it was submitted. Where it has been published in the past it is usually claimed that this photo shows the hit on the Lion's 'Q' turret described in Chapter 1. (Picture: National Archives)

Five photos from this sequence are reproduced here, of which the first three (Fig. 2.4 and Fig. 2.5a and b) show the *Lion* under fire during the 'Run to the South' and give a good illustration of the 'forest of splashes' experienced by the Battlecruiser Fleet at this time.

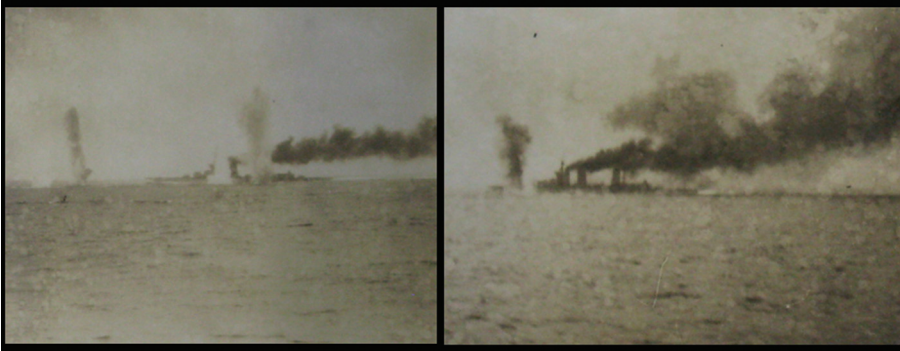
Fig. 2.5 Salvoes falling short of HMS *Lion*. (Picture: National Archives)

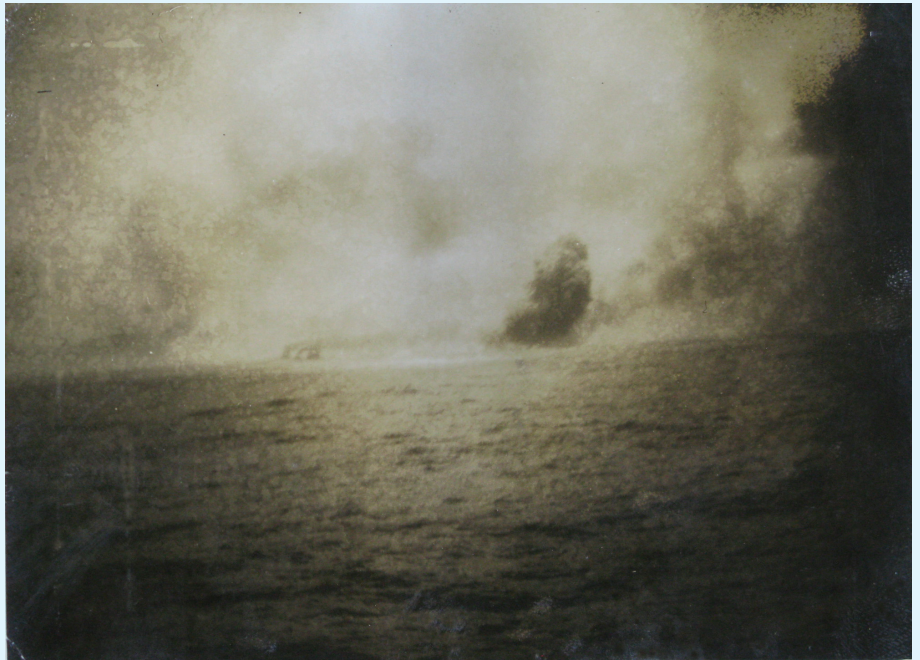
Fig. 2.6 This photograph was captioned by HMS Lydiard's commanding officer as 'New Zealand passing through explosion of HMS Queen Mary' and seems to depict the development of the familiar mushroom cloud seen in Fig. 2.7. (Picture: National Archives)

The next two photographs (Fig. 2.6 and Fig. 2.7) show *Queen Mary* blowing up. They were the last taken by Fawcett during the battle. Interestingly, Fig. 2.6 is sometimes described as being of the *Indefatigable* blowing up, not least in *The Fighting at Jutland*.²³ But the original caption by Lydiard's commanding officer after the battle clearly states that the picture shows the *New Zealand* passing by the explosion of *Queen Mary*.

The angle of the smoke cloud when compared with the famous Fig. 2.7 would seem to confirm that this is likely correct. Sadly, although possibly a rare photograph depicting *Queen Mary*'s end, it is not sufficiently detailed to add much to the story. Fig. 2.7 seems to have been taken shortly after Fig. 2.6 and shows either the development of the same cloud or a later detonation. In either case, it seems to show clearly the venting of smoke and gases upwards after they seemingly have passed through a confined space.

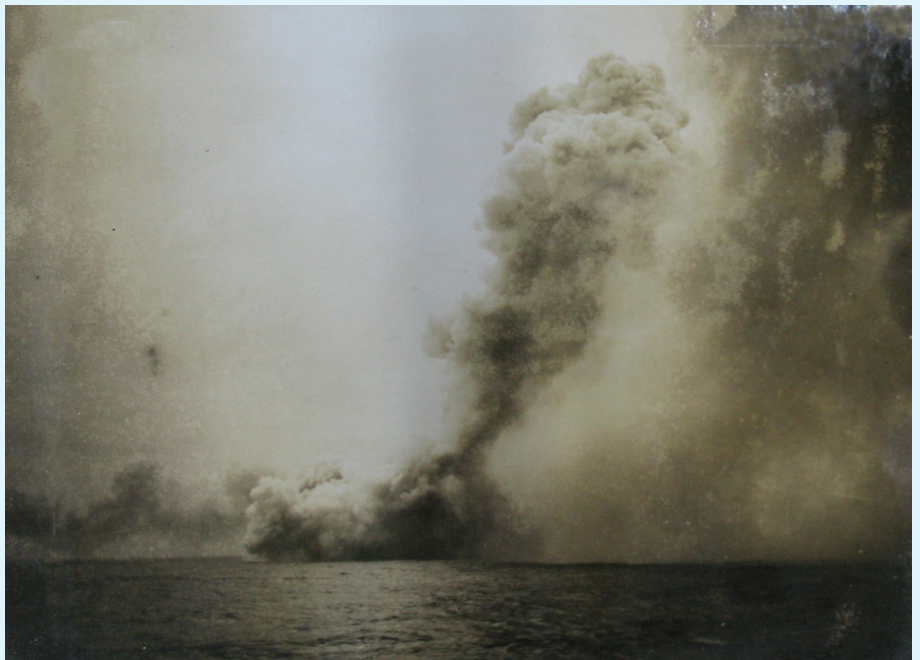
Fig. 2.7 The famous photograph of the explosion of one of the magazines on HMS Queen Mary. (Picture: National Archives)

Fig. 2.7 has appeared in several different iterations made up of other photographs, in order to create a panoramic view of the scene, not least in *The Fighting at Jutland* where it is factually described as a composite image.²⁴ Although not very detailed, Fig. 2.7 is useful because it is a visual confirmation

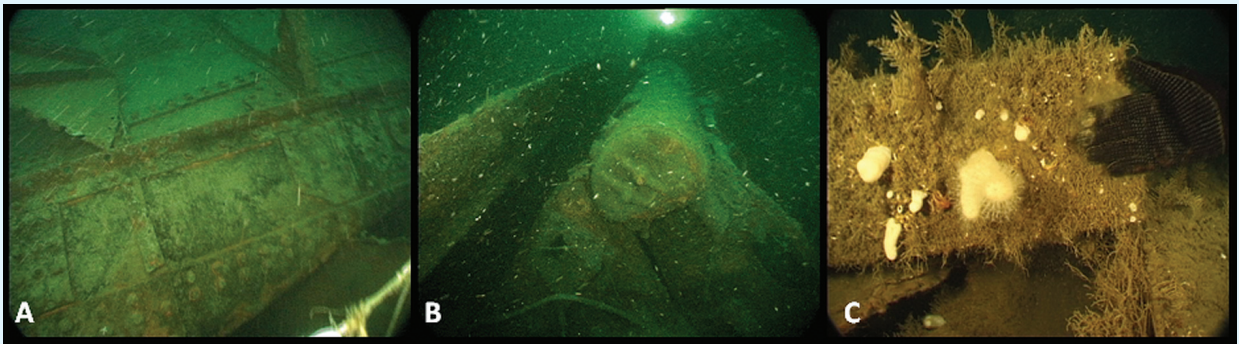
Fig. 2.8 Features observed during the initial dives on the wreck of HMS *Queen Mary* in 2000. A shows the upturned hull of the wreck. B shows the water trough of one of *Queen Mary*'s 42 Yarrow boilers, with the locking bars for the inspection hatch. The wreck is upside down so the water troughs represent some of the highest points of the wreck today. C shows a section of the ship's 9-inch armour belt, with my hand for scale.

This was achieved by locating a section of her 9-inch armour plate which was unique among the Jutland wrecks. Many other items, such as the 4-inch guns and the plethora of Yarrow boilers (*Queen Mary* was equipped with an unprecedented 42 of them, to deliver her high speed), were indicative that this could be no other shipwreck. Because of what is known of the sinking, we concluded that the largest piece of wreckage located on our bottom sounder had to be the stern section of the ship which was witnessed to be intact at the moment of sinking. Images of this stern portion can be seen in Fig. 2.8 and Fig. 2.9.

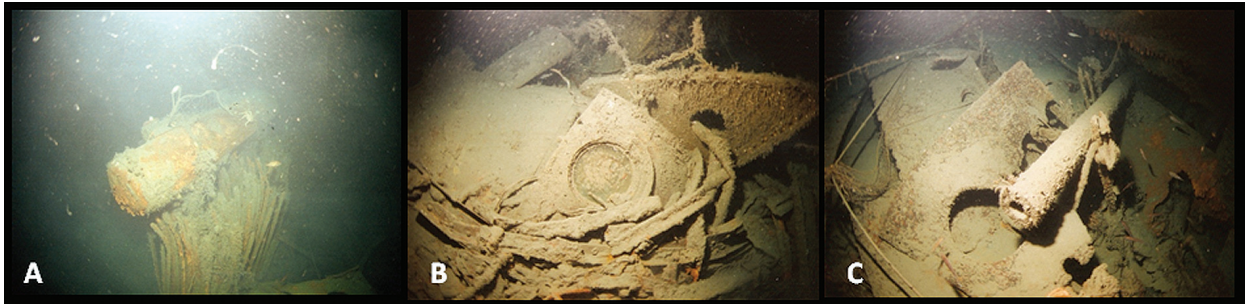
Fig. 2.9 Features observed during the initial dives on the wreck of HMS *Queen Mary* in 2000. A is another water trough standing proud of the wreck. Much of the surrounding structure has now collapsed well down into the wreck. B shows a porthole which has rotted out of the now collapsed superstructure. C depicts the barrel of one of *Queen Mary's* 4-inch guns poking out from under a plate that has fallen on to it. (Pictures: Patricia McCartney)

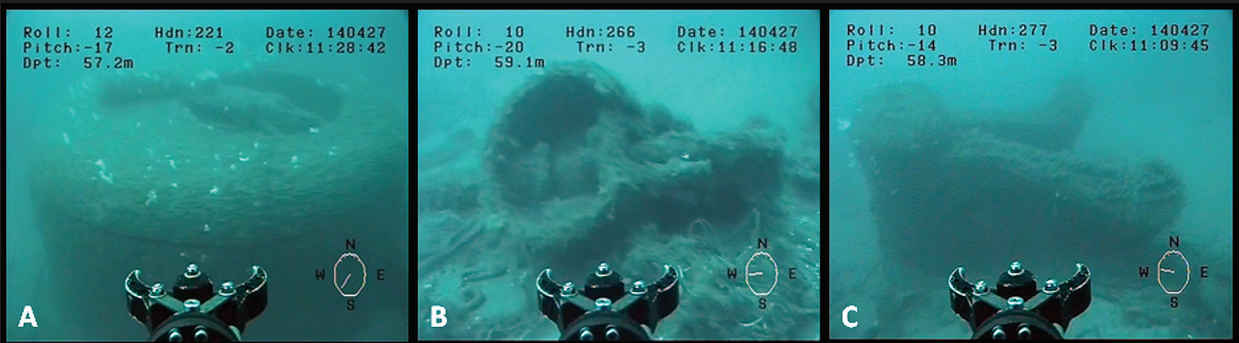
Fig. 2.14 Features observed during the ROV survey of the forward section of the wreck in 2014: A shows the armoured conning tower sitting upright on the seabed, seeming totally undamaged, but missing the range finder from its roof. B shows a 4-inch gun found in the extreme north-west of the wreckage area. C shows an entire Yarrow boiler lying isolated on the seabed. (Pictures: McCartney/JD-Contractor)

The 2014 ROV survey also revealed a number of new features unseen before (Fig. 2.14). Of particular note was the armoured conning tower, sitting upright

As the ROV made its way to the east, back to the large portion of the wreck, the seabed was seen to be strewn with wreckage in a widely scattered debris field, including the uncanny sight of an entire Yarrow boiler lying isolated on the seabed, as seen in Fig. 2.14.

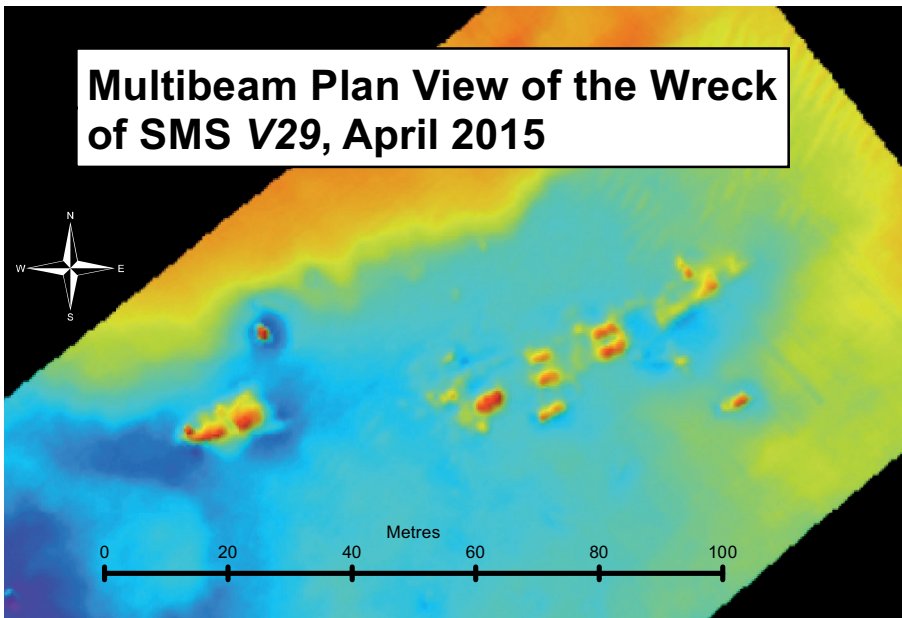
Fig. 3.4 Multibeam plan view of the SMS V29 wreck, as seen on Vina's multibeam system in April 2015. (Picture: McCartney/JD-Contractor)

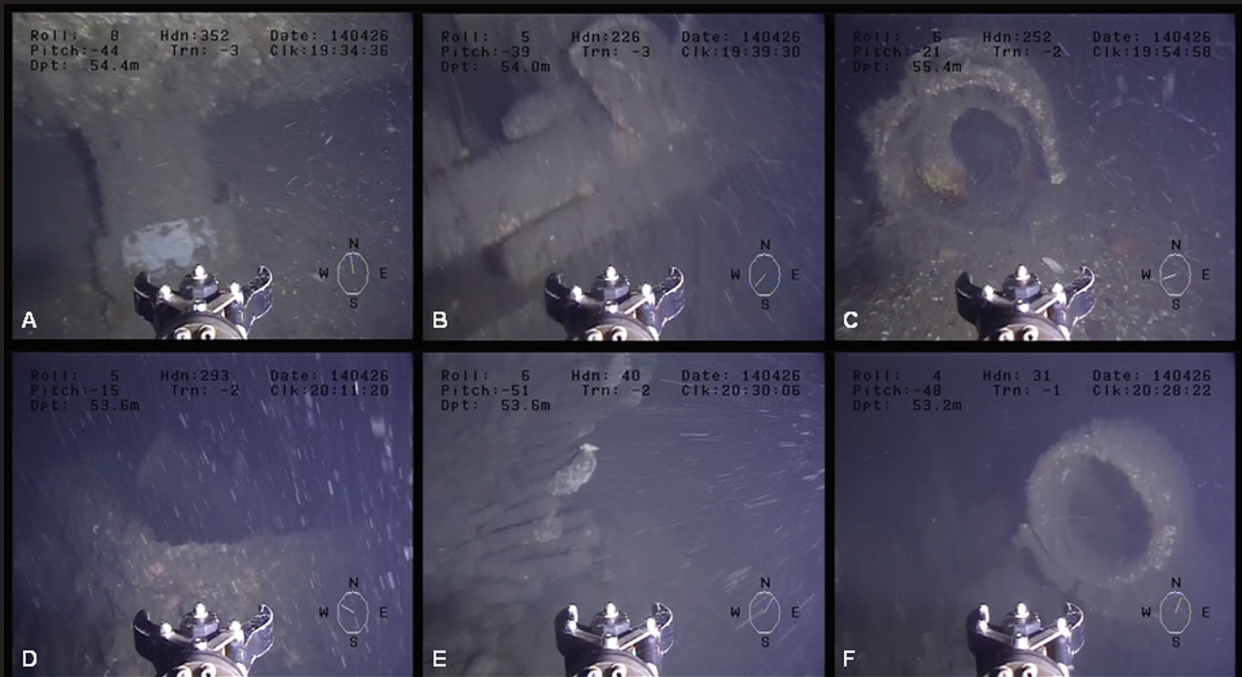
Fig. 3.5 Key features identifying this wreck, now known as SMS V29, to be of German build. (Pictures: McCartney/JD-Contractor)

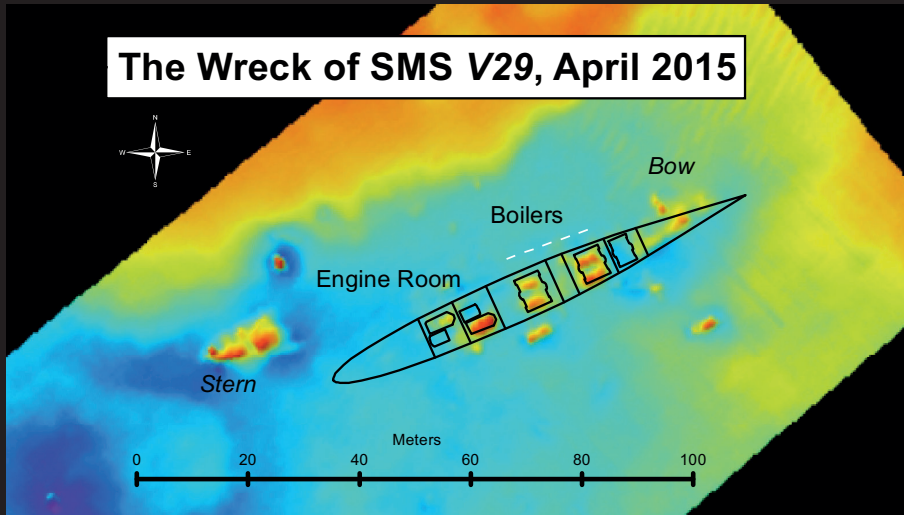
Fig. 3.6 The hull form and machinery distribution plan for SMS V29 overlaid on the plan view of the multibeam image reveals that the wreck is definitely of German type. (Picture: McCartney/JD Contractor)

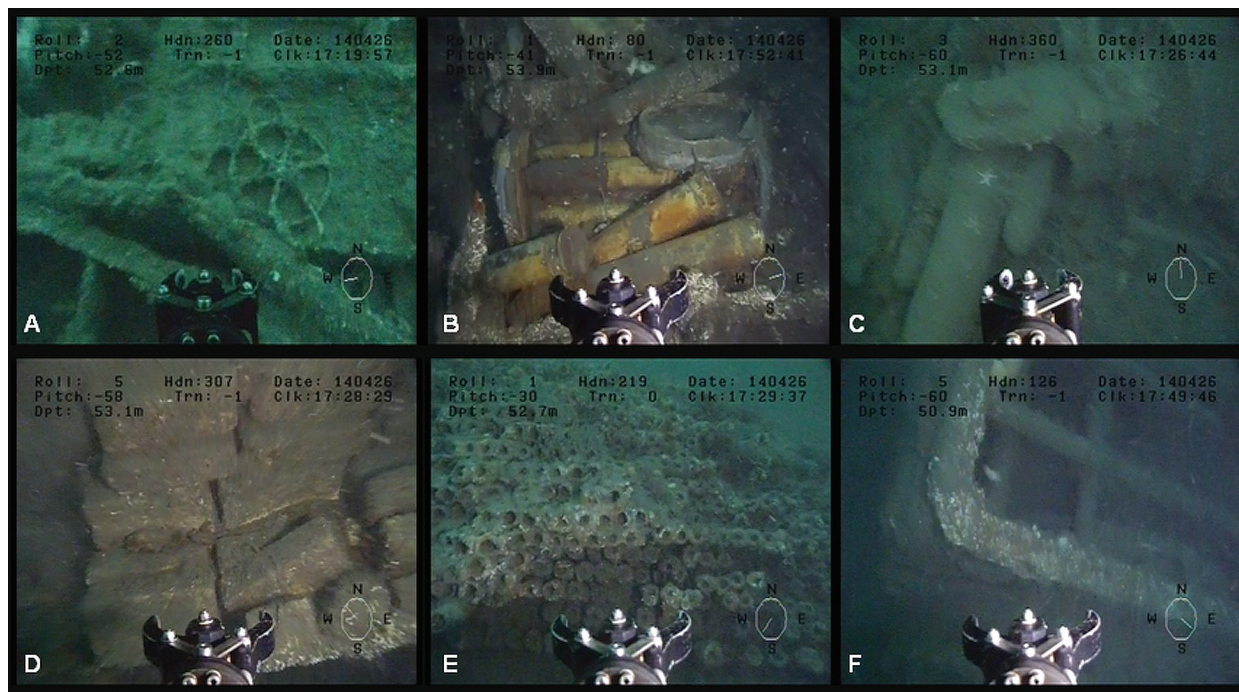
Fig. 3.8 Key features identifying this wreck, now known as SMS V27, to be of German build and similar to V29. (Pictures: McCartney/JD-Contractor)

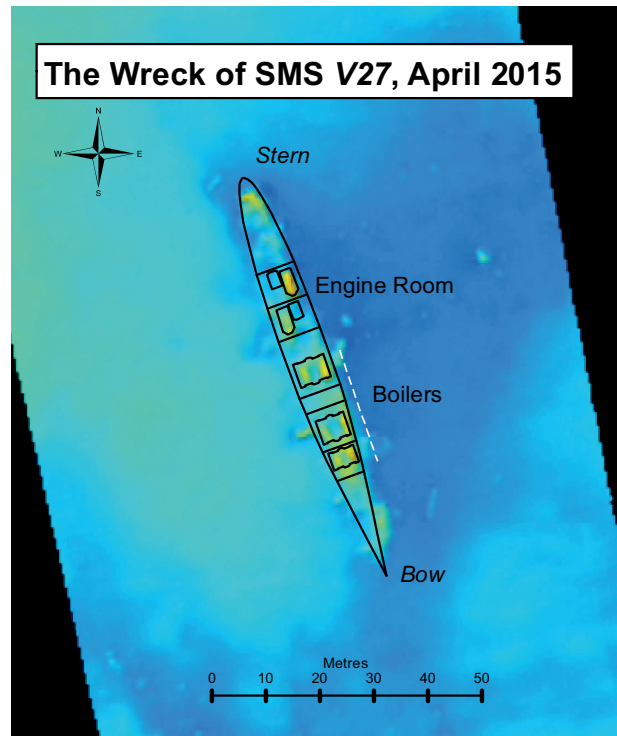
Fig. 3.9 The hull form and machinery distribution plan for SMS V27 overlaid on the plan view of the multibeam image reveals that the wreck is definitely of German type and most probably V27. (Picture: McCartney/JD-Contractor)

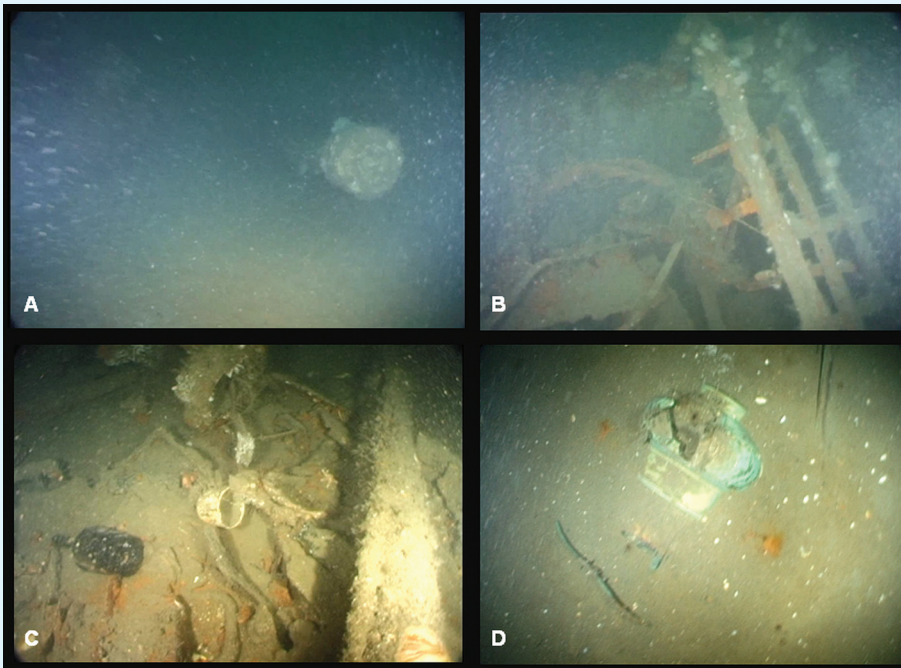
Fig. 3.10 Images from the wreck of HMS Nomad taken in 2001 on the day it was first dived.

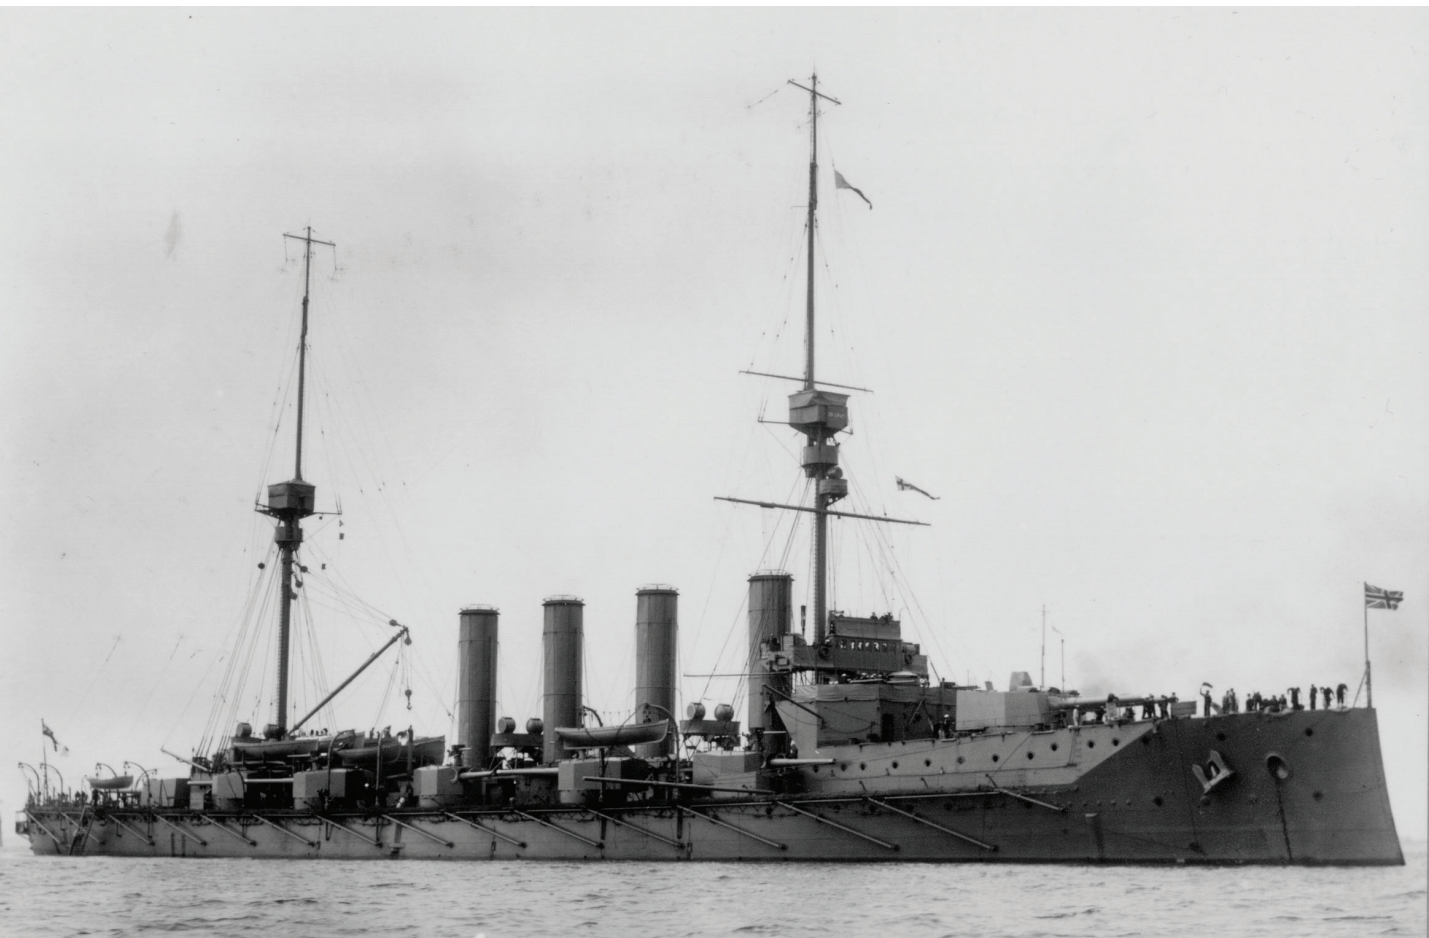
Fig. 4.1 Admiral Arbuthnot's flagship, HMS Defence, launched in 1907. Displacement 14,600 tons, length 520 ft, four 9.2-inch guns, ten 7.5-inch guns. The twelve gun turrets make her class unmistakable. (Picture: Imperial War Museum Q21149)

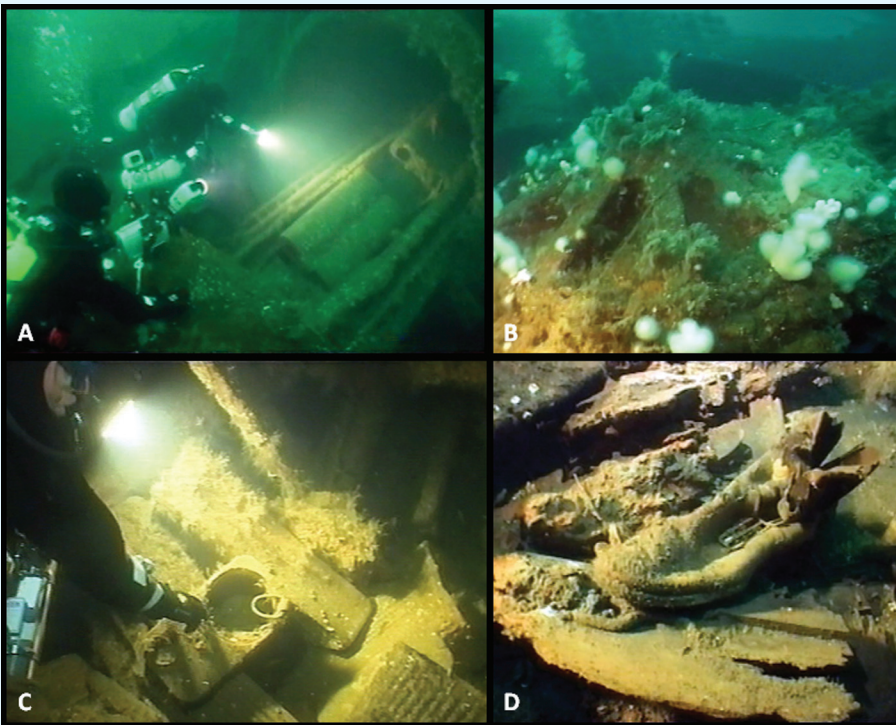
Fig. 4.6 Items observed on the wreck of HMS *Defence* in 2003 as described in the text. (Pictures: McCartney/Ideal World Productions)

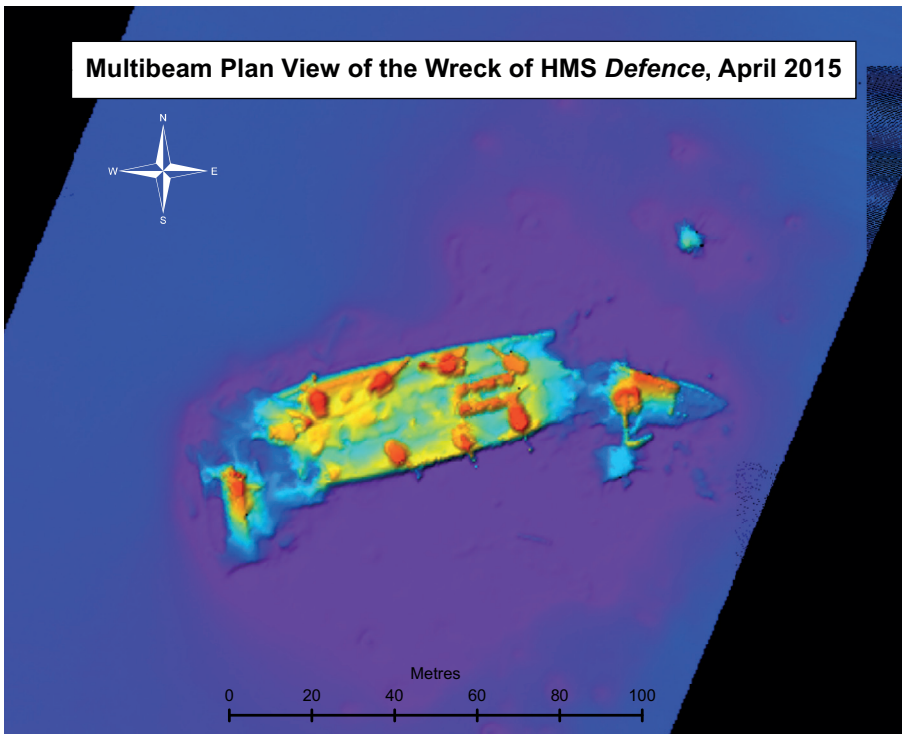
Fig. 4.7 Plan view of the wreck of HMS *Defence* as recorded by *Vina* on multibeam in April 2015. (Picture: McCartney/JD-Contractor)

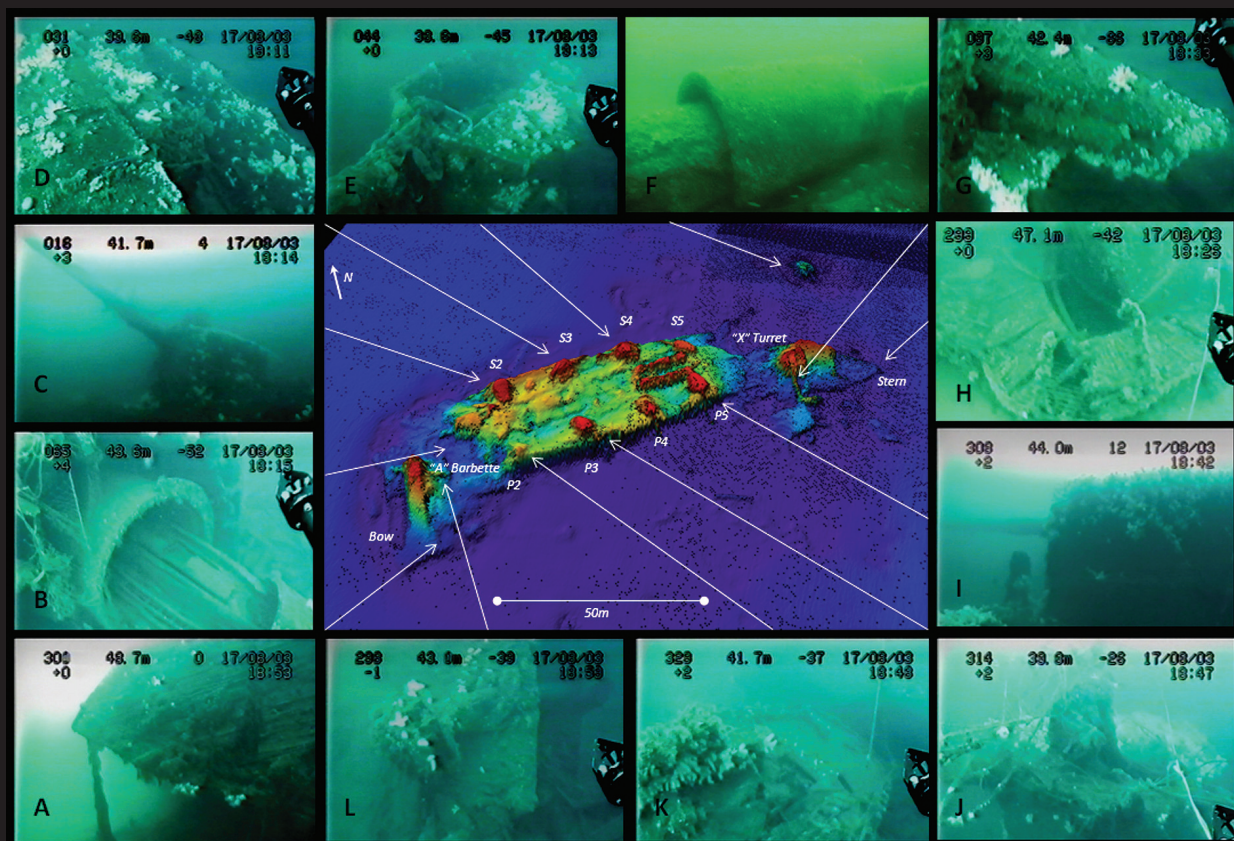
Fig. 4.8 How HMS Defence looks today, using the multibeam record as a basis for a visual tour of some of the wreck's features. (Pictures: McCartney/JD-Contractor/Ideal World Productions)

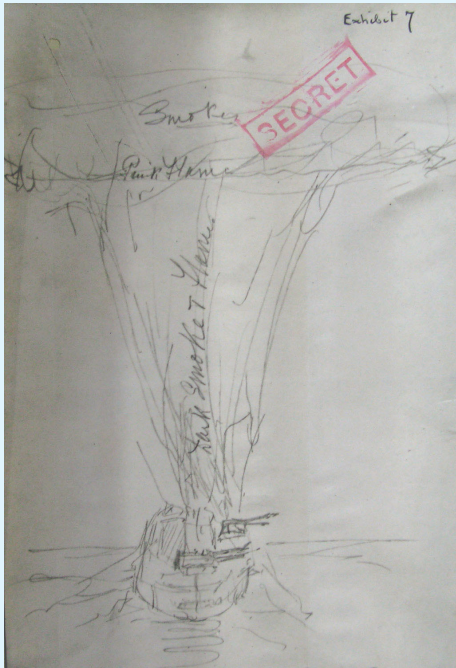
Fig. 5.4 Captain Carslake's sketch of the moment when he saw the *Invincible* blow up at Jutland, as recorded during the inquiry into the loss of HMS Hood in 1941. (Picture: National Archives)

Carslake was then asked to make a pencil sketch of what he saw, which to my knowledge is the only one that has endured. It shows how Carslake remembered the strike on 'Q' turret of the *Invincible* and the flames emitted (Fig. 5.4).

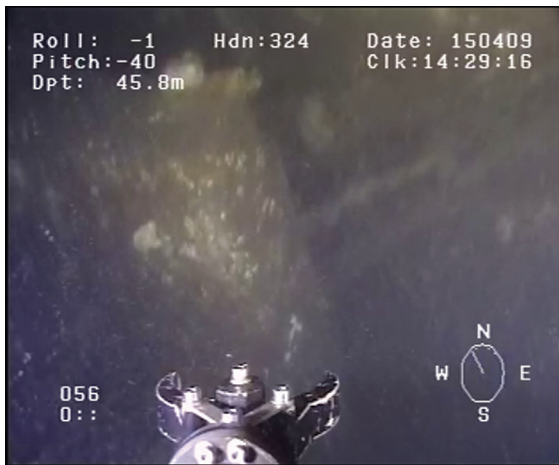
Fig. 5.13 The curved armoured plate of 'X' turret sleeve, as seen during the 2015 ROV survey. The curved plate seen displaced in 2001 has now completely fallen out, leaving a void on the right-hand side of the image. (Picture: McCartney/JD-Contractor)

was deployed to examine the stern portion of the wreck. The curved plate has now fallen out completely (Fig. 5.13).

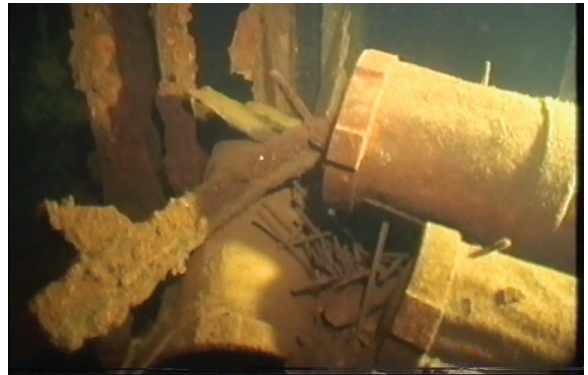
Fig. 5.14 Piles of cordite cases now collapsed on each other, as seen in the area underlying 'X' turret in 2003. (Picture: McCartney/Ideal World Productions)

The underlying handling room and magazines appeared to have experienced some state of collapse when divers inspected that area from the port side in 2003. In deference to the site being a grave, the area was not entered, so this conclusion is only tentative (see Fig. 5.14) but is supported by the overall condition of the stern section and the jumbled nature of the cordite cases seen in the area.

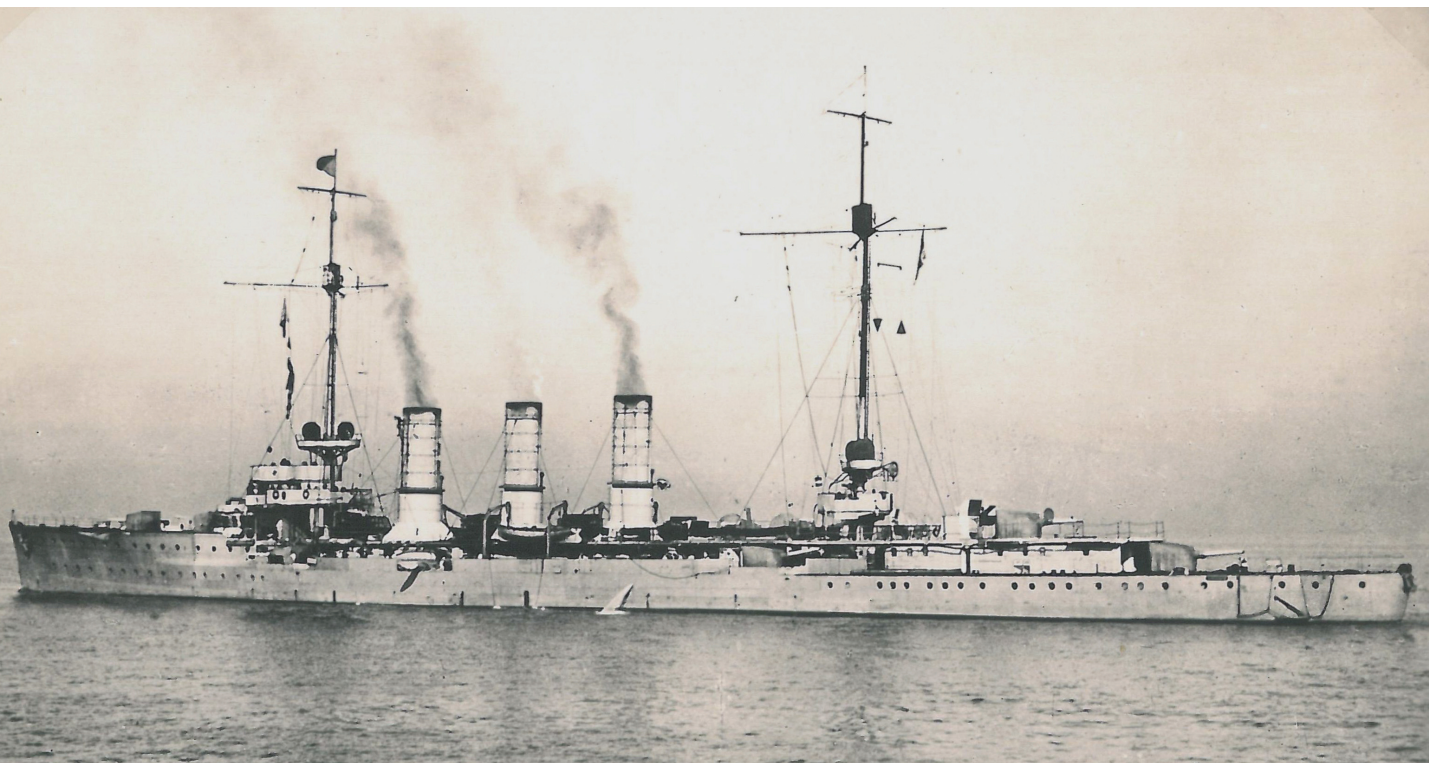
Fig. 6.1 SMS Wiesbaden as seen from the port side. The 5.9-inch gun turrets were arranged with a pair forward and aft (superfiring) and two along each side. Launched in January 1915, she had a displacement of 5,120 tons and length of 477 ft, with eight 5.9-inch guns, two AA guns and four 19.7-inch torpedo tubes. (Picture: Archiv Deutscher Marinebund)

SMS *Wiesbaden* (Fig. 6.1) was the named ship of her class, which was the first class of light cruisers purposely designed to take the 5.9-inch gun, although earlier classes received retrofits.¹ The eight main guns were fitted in single casemates, two forward, two down each side and a superfiring pair to the stern. Secondary armament consisted of anti-aircraft guns and four torpedo tubes. The ship was commissioned in August 1915 and saw her first major action at the Battle of Jutland, where she formed part of the Second Scouting Group, consisting of her sister ship SMS *Frankfurt* (the lead ship), followed by the *Pillau*, *Elbing* and *Wiesbaden* screening the battlecruisers of the First Scouting Group.

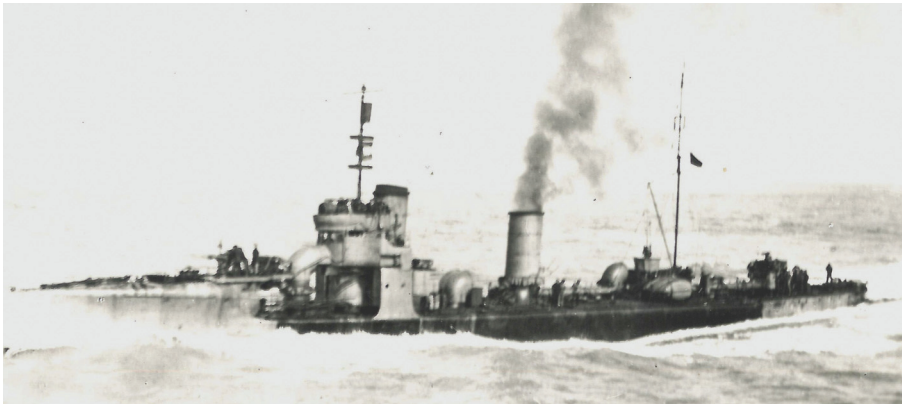
Fig. 7.7 The torpedo boat SMS V48, as seen underway. Length 272 ft, displacement 924 tons, with three 3.46-inch (88 mm) guns of 45 calibre, mounted singly fore, central and aft, and six 19.7-inch torpedo tubes (single tube each side at the bow and two double mounts central and aft). (Picture: Archiv Deutscher Marinebund)

SMS V48 was of the V25 class of torpedo boats, similar to V27 and V29 as described in [Chapter 3](#). V48 was slightly heavier and longer, but in most details was similar. Fig. 7.7 shows a photograph of SMS V48 in service.
